Product Bulletin # TDS-251 Rev 2

Mudline Mount Inspection

Canrig Top Drives models C500 and C750 (formerly 1250AC and 1275AC)

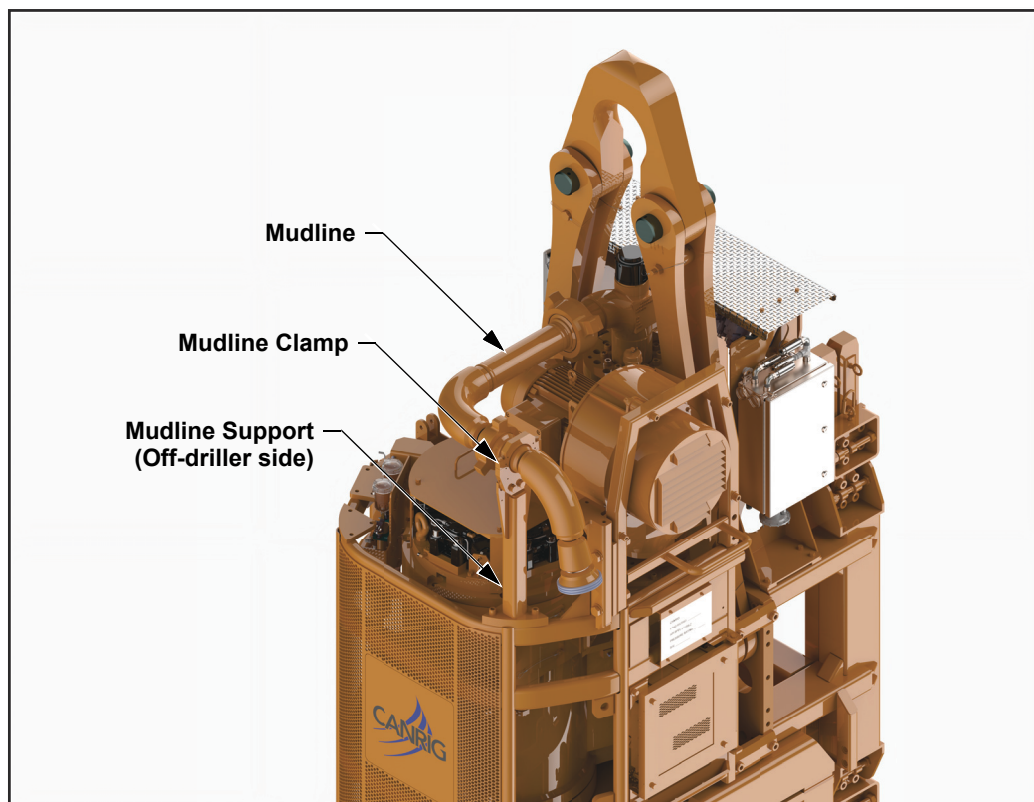
Figure 1: Mudline mount and clamp

High wind conditions may contribute to causing the rotary hose to distribute a high load on the mudline and mudline mount.

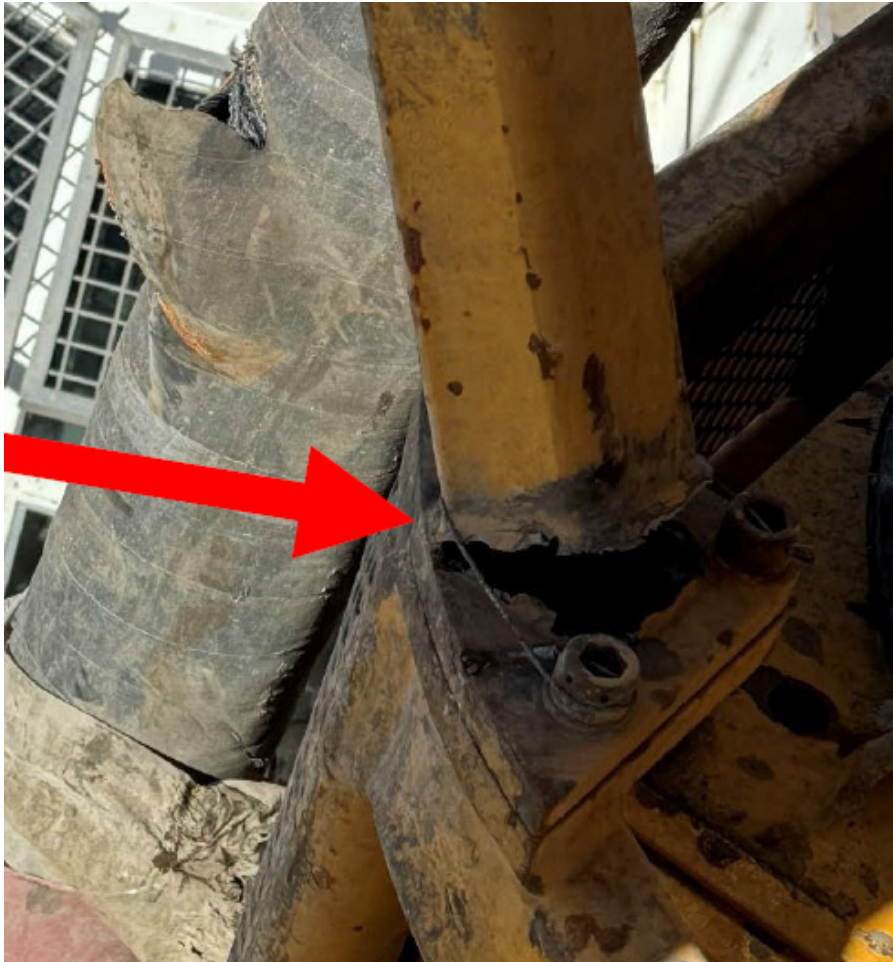
Figure 2: Mudline side mount

1. Visually inspect all the weld joints on the (ODS or DS) off-driller's side mount (P/N: DT33527-ODS) and drillers side mudline mount (P/N: DT33527-DS) particularly between the square tubing and the triangular base plate as shown in Figure 2. If welds indicate cracks or breaks, record and contact [Canrig Part Sales](#) for replacement.

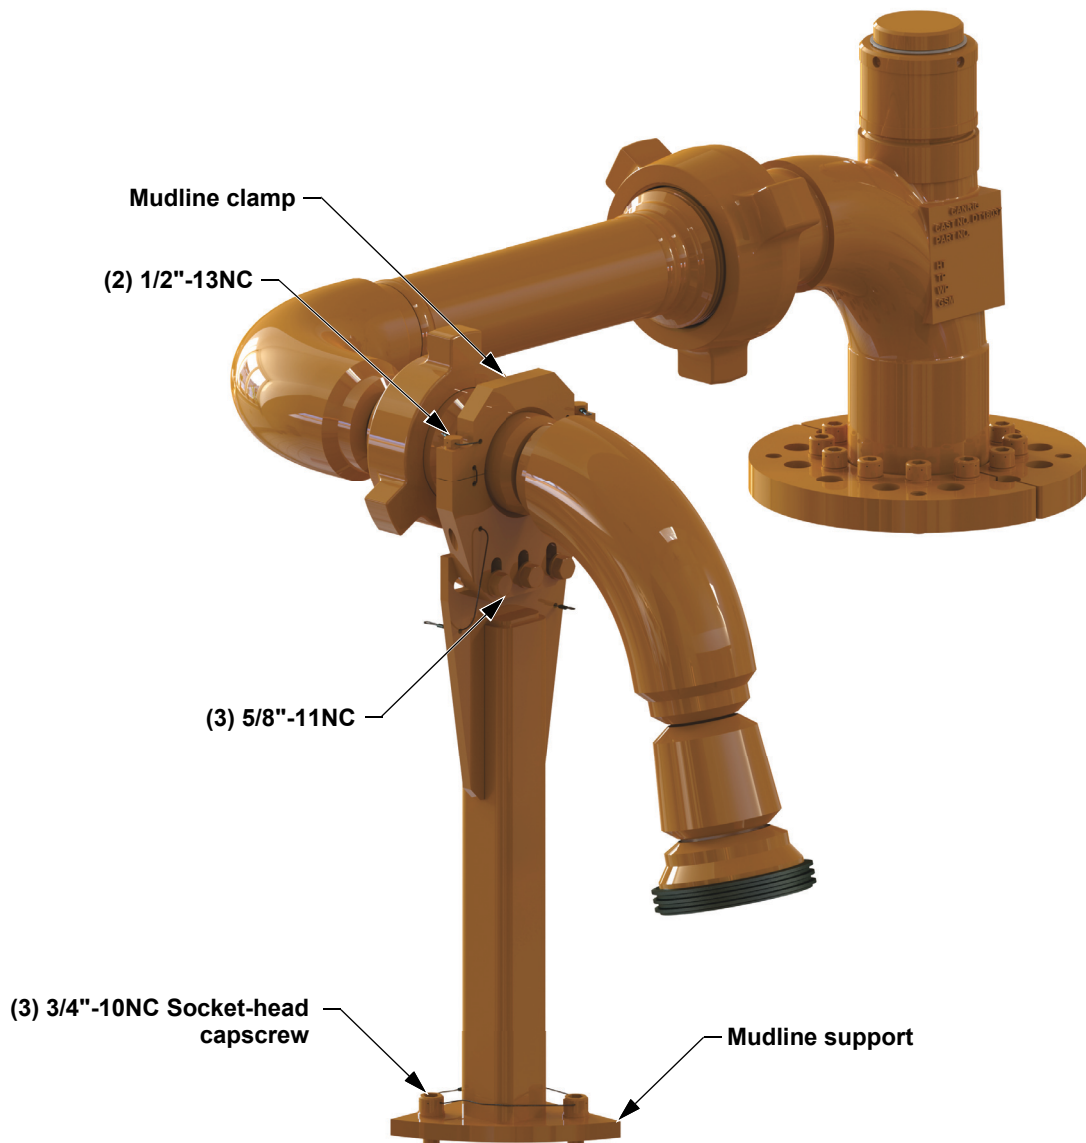
Figure 3: Secondary retention on mudline mount

2. Visually inspect the mudline mount and clamp to ensure secondary retention and safety securement has been installed and secured as shown in Figure 3. Refer to bulletin "[Mudline Clamp Alert](#)" (TDS-155) for further guidance on mudline clamp installation.
